ACCUSCRIBE™

How to verify the reading is properly completed

Overview

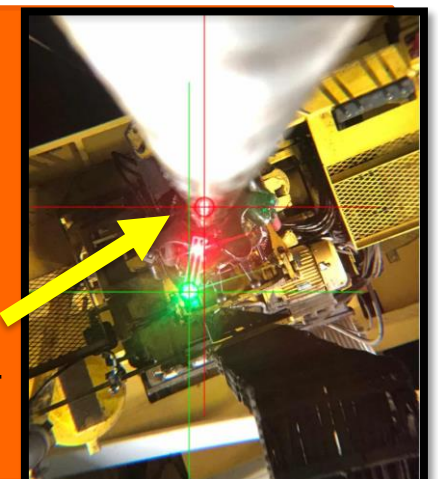
Crosshair Verification Photo -
Verify that the red and green crosshairs are overlaid in the center of the green and red lights.

Note - It is important the user didn't select a reflection or glare that is not the light. The generally happens when the red light reflects off the drill pipe or non-magnetic collar.

Correct

Incorrect

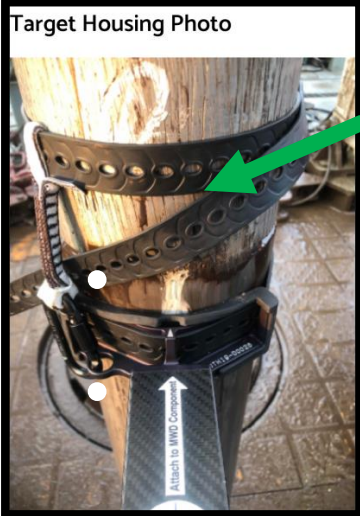
Target Housing Photo -
Ensure the target housing is perpendicular to the MWD highside

Safety - Fall restraint is attached

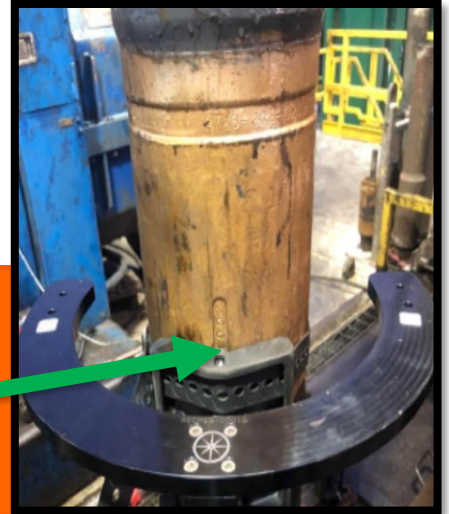
Camera Mount Photo - Ensure the motor mount is perpendicular to the mud motor highside.

Safety - Do not put your hands in between the magnets and the mud motor
